Manhole Inspection Summary

Manhole # S21CC_035MH

Insp Date: **10/22/07 1:27 PM**

Location Address: **1112 ALLEY-MCKEAN-FULTON**

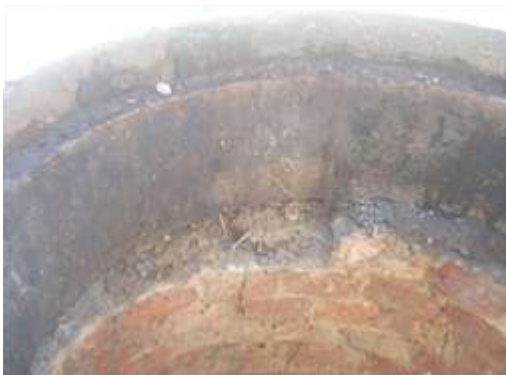
Defect 4

Condition: ☐ Sound ☐ Cracked ☐ Root Intrusion ☐ Loose Brick ☒ **Deteriorated**

DETERIORATED CORBEL

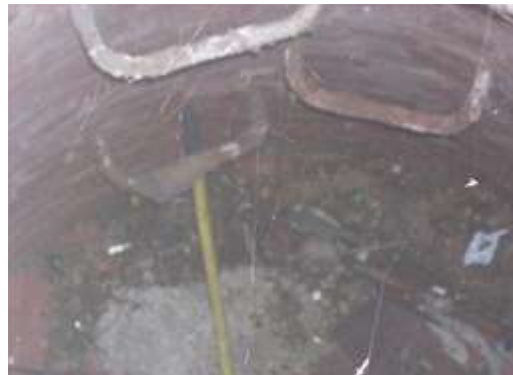
Defect 3

Count: **4** Missing: **0** ☒ **Corroded**

CORRODED STEPS

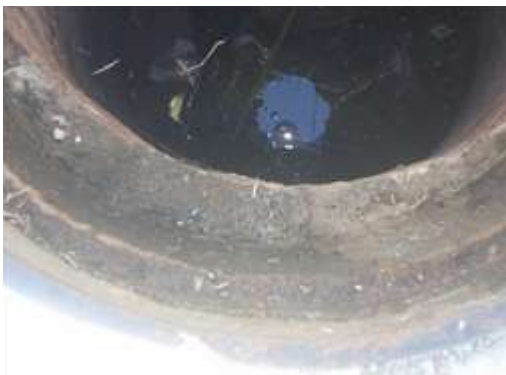
Defect 2

Offset: **1** (in.)

FRAME OFFSET

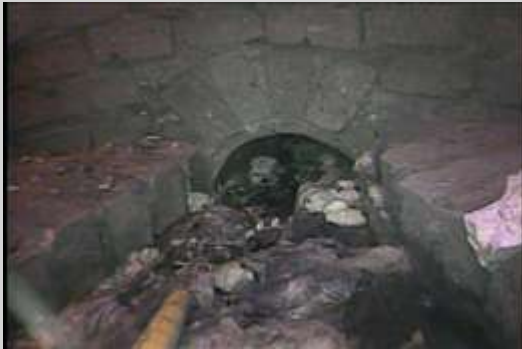
12 O'Clock Outflow

Pipe Height: **8.4** (in.) Rod and Bar (Angled)
Pipe Material: **Clay** ☐ Pipe Lined
Invert Depth: **8.89** (ft.) Flow Characteristics: **Slow**
Deposits: ☐ None ☐ **Mud** ☒ **Sludge** ☒ **Debris** ☐ Grease
Silt Depth: **6** (in.) Deposits Extent: **Heavy**
Infiltration: **None** Pipe Seal Cond: **Sound**

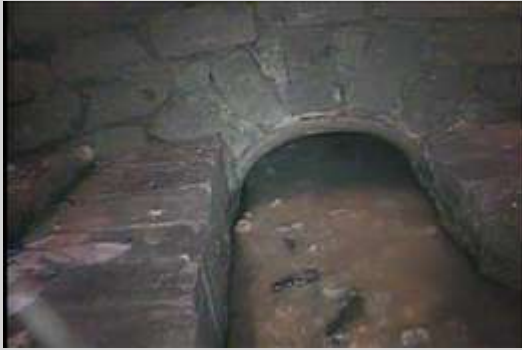
9 O'Clock Inflow

Deposits: ☐ None ☒ **Mud** ☐ Sludge ☒ **Debris** ☐ Grease

Silt Depth: **5** (in.) Deposits Extent: **Heavy**
